Leviathan Mine Site
Interim Combined Treatment
Upper Pond Conveyance System (UPCS) Project
Daily Report
April 27, 2017

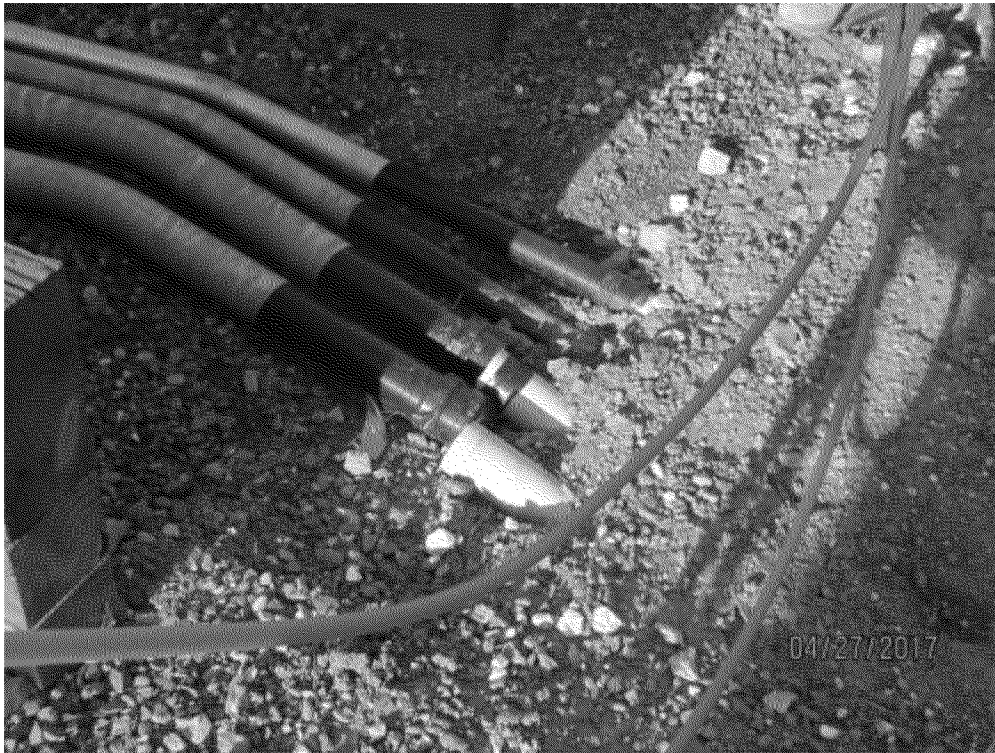
- Lower slope stability issues near Pond 4 (see Safety and Environmental issues above).
- Electrical conduit connection from rigid metal to PVC near Pond 4 has come loose and needs to be cleaned out and reconnected (see photos).

Loose electrical conduit near Pond 4.

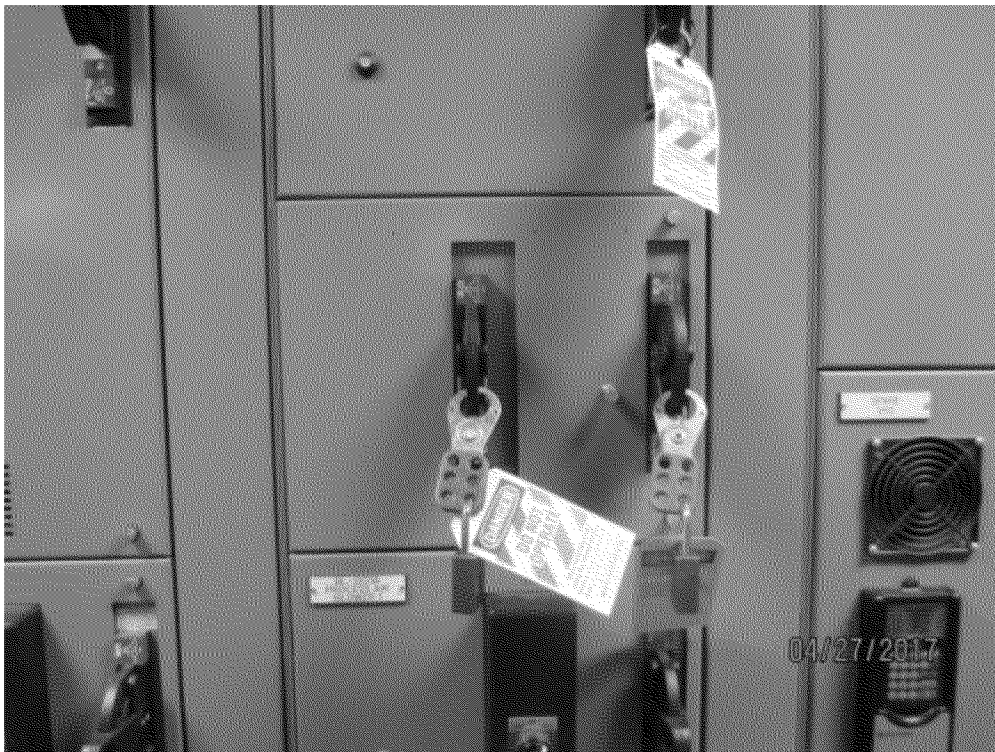
- Electrical – Briggs performed a site orientation, inspected current conditions, and reviewed work action items. Briggs also installed the breaker box in the HDS power trailer. Briggs will be gathering required supplies and is scheduled start work on Monday 5/1, working four 10-hr days per week, Monday-Thursday. Anticipated crew is 7-10 people.

Breaker box installed in HDS power trailer.

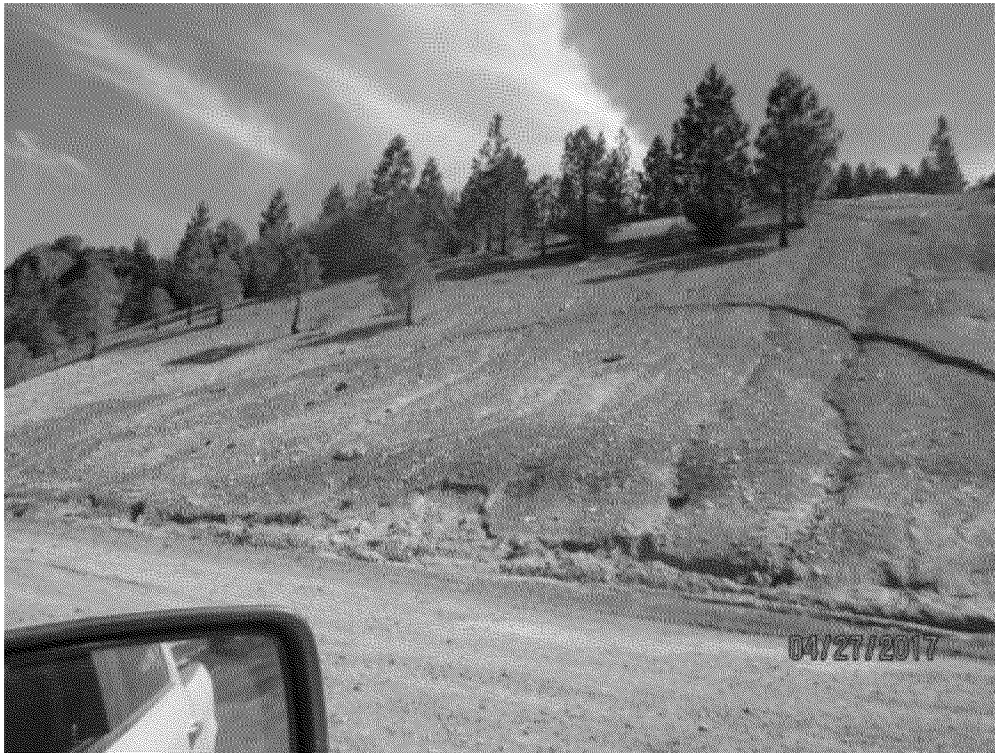
- Around 10:00am this morning a small slough was noted along the lower slope south of Pond 4. The slough was not noted yesterday. A tension crack was also noted along the crusher and Pond 3 access road above the lower slope from around the Pond 4 parking lot up to Pond 3. Site safety and oversight personnel unanimously agreed that the access road along the slope toe from Pond 4 to Pond 1 was not safe to drive due to concerns of the slope sloughing into the road. Both the crusher access road and toe access road to Pond 1 were blocked off to prevent access until further geotechnical evaluations can be performed to determine if the slope is in danger of sloughing into the roads. Due to access restrictions, USA left the site at 10:45am today.

Slope sloughing along access road near Pond 4.

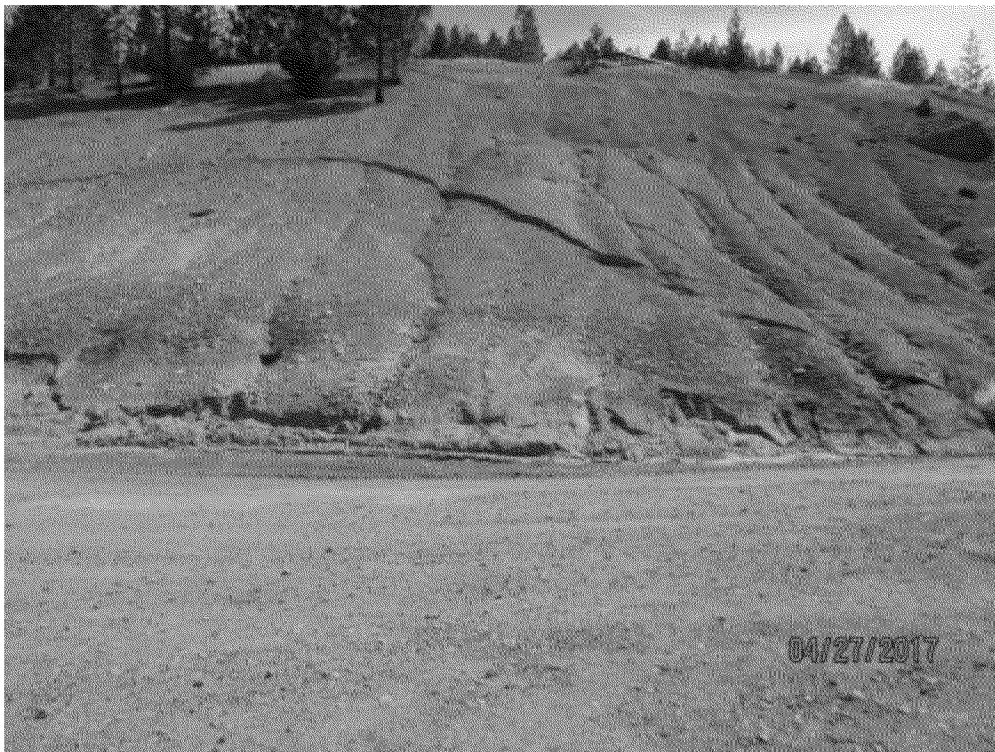
Slope sloughing along access road near Pond 4.

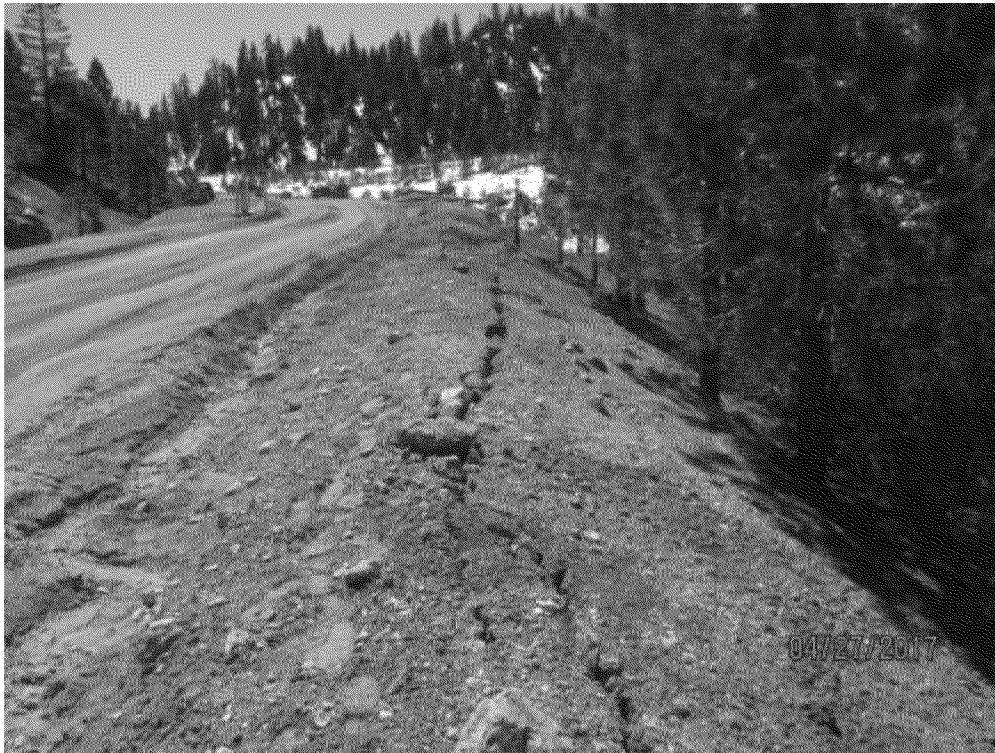
Tension cracking along crest of lower slope near Pond 4.

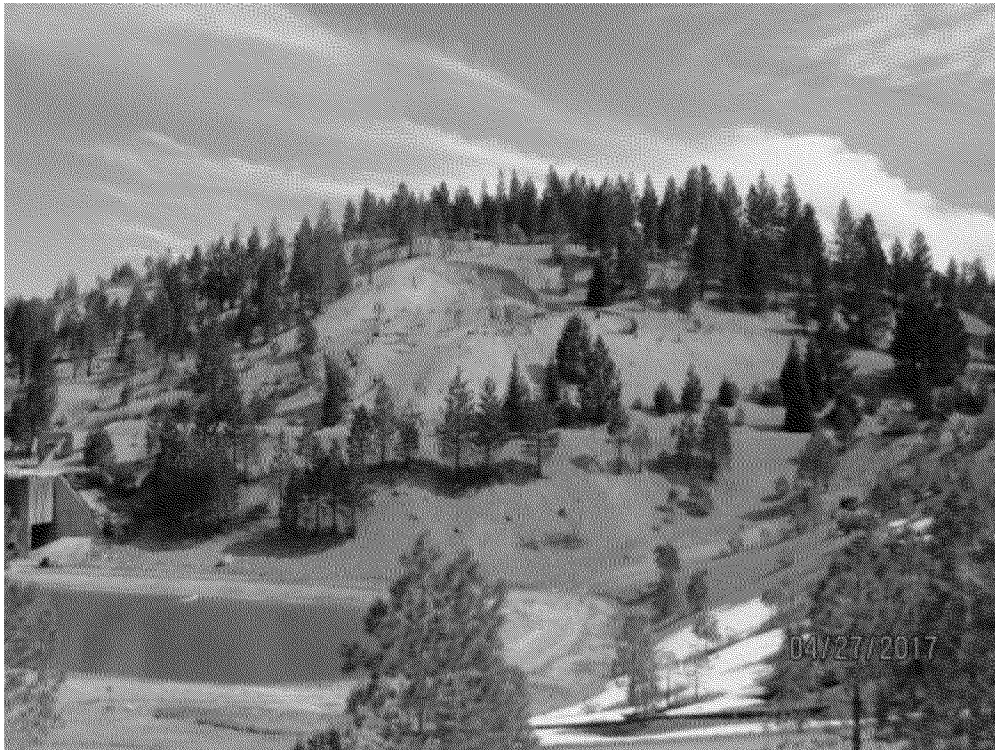
Slope sloughing along upper slope, east of Pond 3.
